Manhole Inspection Summary

Manhole # S27I__022MH

Location Address: **868 Parkins St**

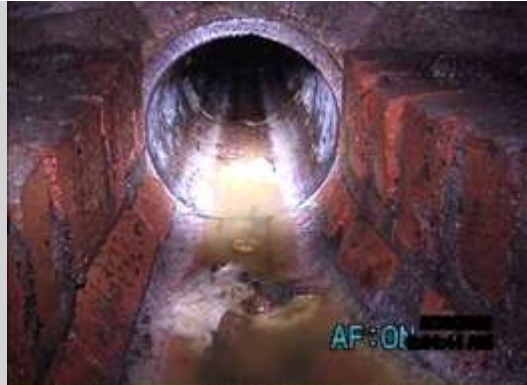
12 O'Clock Outflow

Pipe Height: **8.4** (in.) Rod and Bar (Angled)
Pipe Material: **Clay** ☐ Pipe Lined
Invert Depth: **10.69** (ft.) Flow Characteristics: **Slow**
Deposits: ☒ None ☐ Mud ☐ Sludge ☐ Debris ☐ Grease
Silt Depth: **0** (in.) Deposits Extent:
Infiltration: **None** Pipe Seal Cond: **Sound**

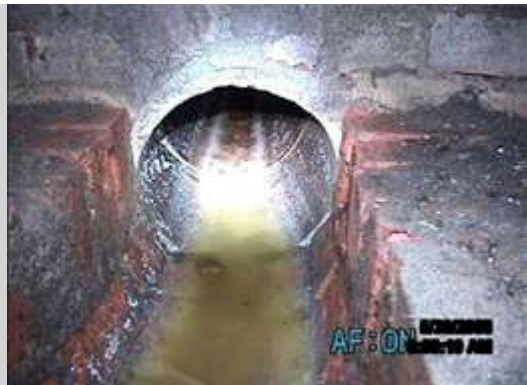
3 O'Clock Inflow

Pipe Height: **8.4** (in.) Rod and Bar (Angled)
Pipe Material: **Clay** ☐ Pipe Lined
Invert Depth: **10.67** (ft.) Flow Characteristics: **Slow**
Deposits: ☒ None ☐ Mud ☐ Sludge ☐ Debris ☐ Grease
Silt Depth: **0** (in.) Deposits Extent:
Infiltration: **None** Pipe Seal Cond: **Sound**

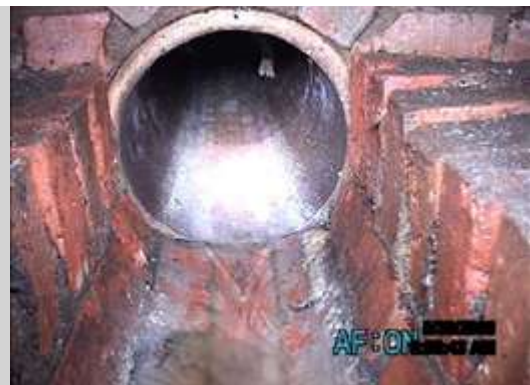
6 O'Clock Inflow

Pipe Height: **8.4** (in.) Rod and Bar (Angled)

Infiltration: **None** Pipe Seal Cond: **Sound**
